INTERLUDE AT ELGIN VALE

A STEAM DRIVEN SAWMILL ENGINE
GETS A NEW LEASE OF LIFE

DURING THE INDUSTRIAL REVOLUTION, ALL OVER THE WORLD,
STEAM ENGINES WERE THE MAIN SOURCE OF POWER TO DRIVE
OUR MACHINES. THIS IS THE STORY OF
AN OLD MILL ENGINE
IN A SAWMILL IN COUNTRY QUEENSLAND

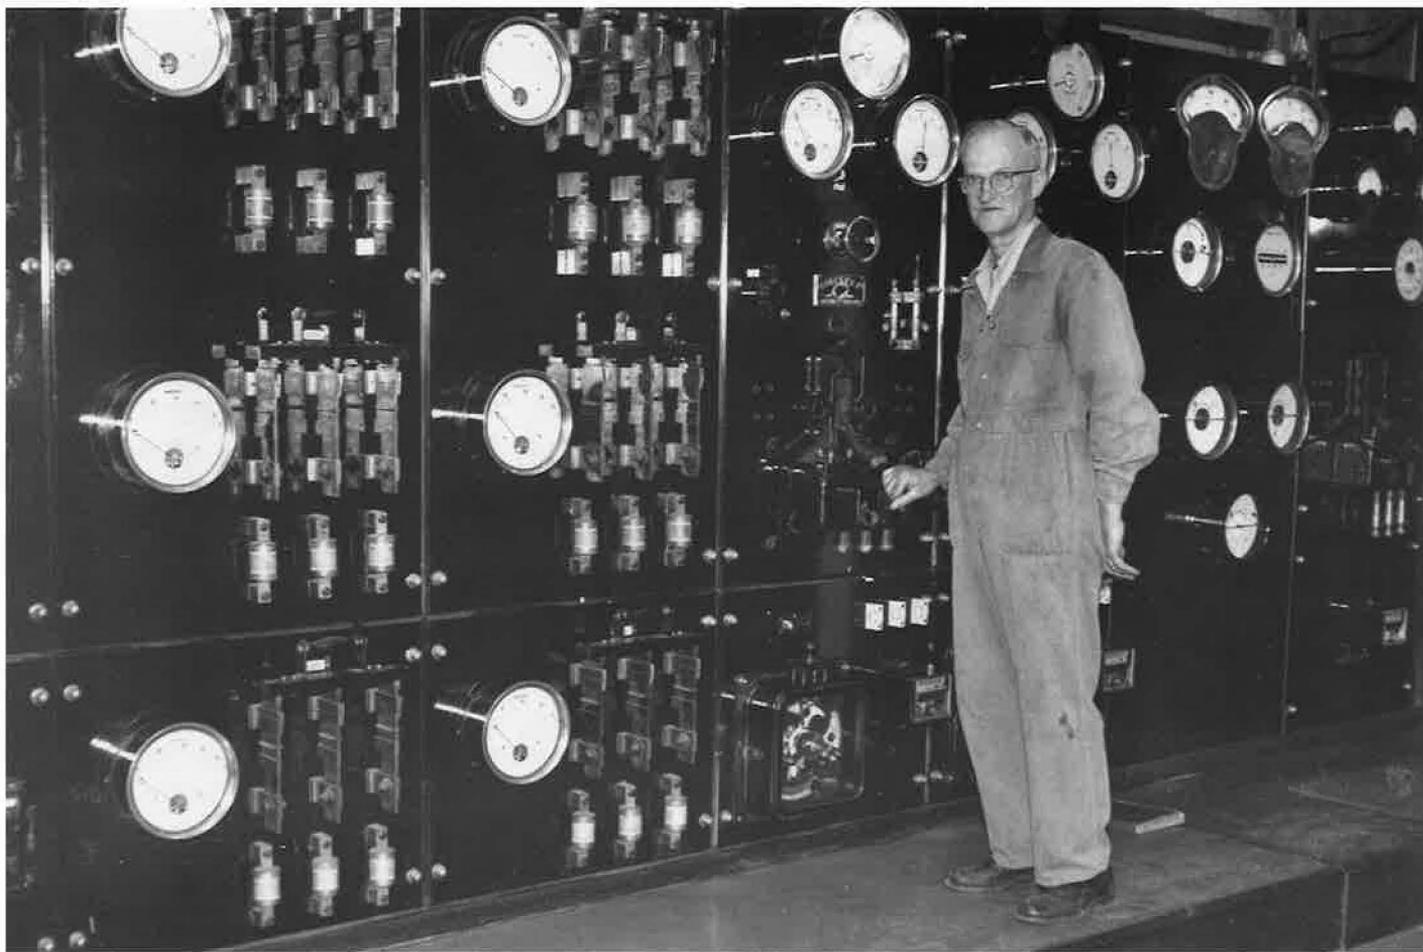
One of a number of photographs “commissioned” in 1957 by the late George Creed-Jacobs by well known Maryborough Photographer, Mr. R. G. Parry.

CAMERON (MACK) McKECHNIE is positioned at the switch board in the engine room which was his domain at the time. During the war years the Mill supplemented the power supply to Maryborough through this switch board.

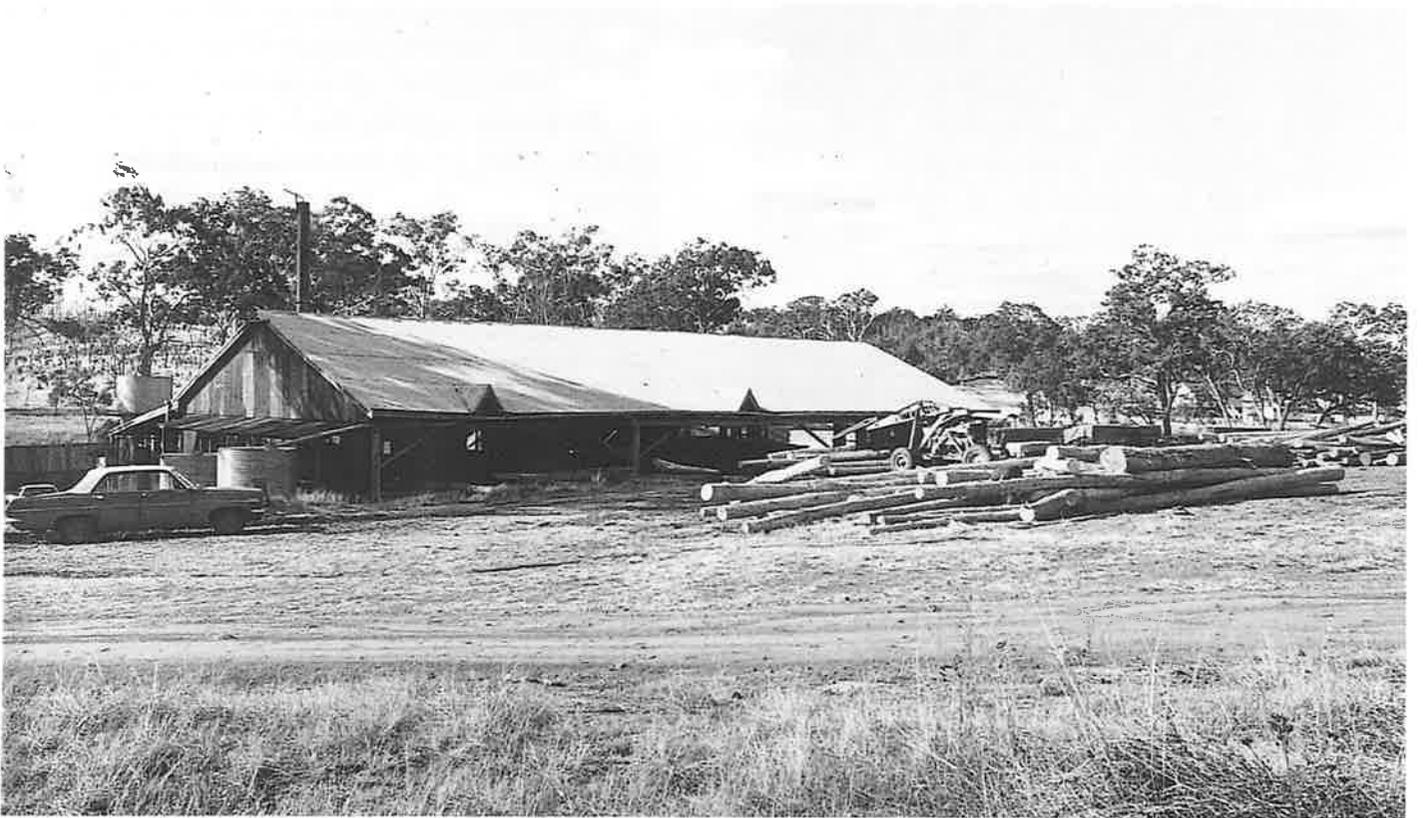
Timber trucks dumped their log loads on the top side of the mill where they were easily loaded on to the moving carriage of the Canadian Bench for breaking down.

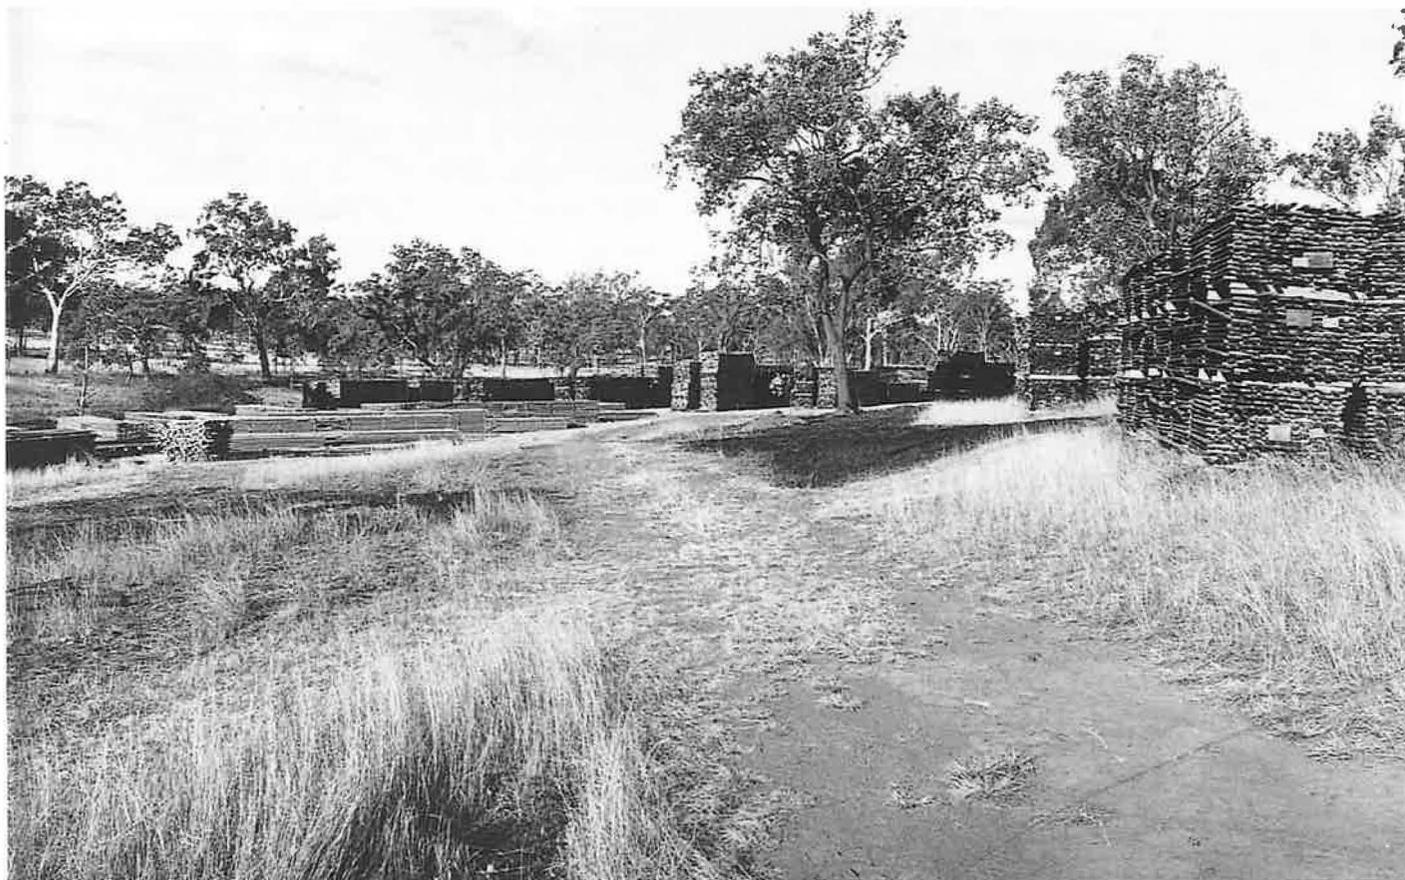
The large open spaces at the far end of the mill held many big stacks of pine planks carefully stripped up for natural air drying. All were cut with power supplied by the old Robinson engine.

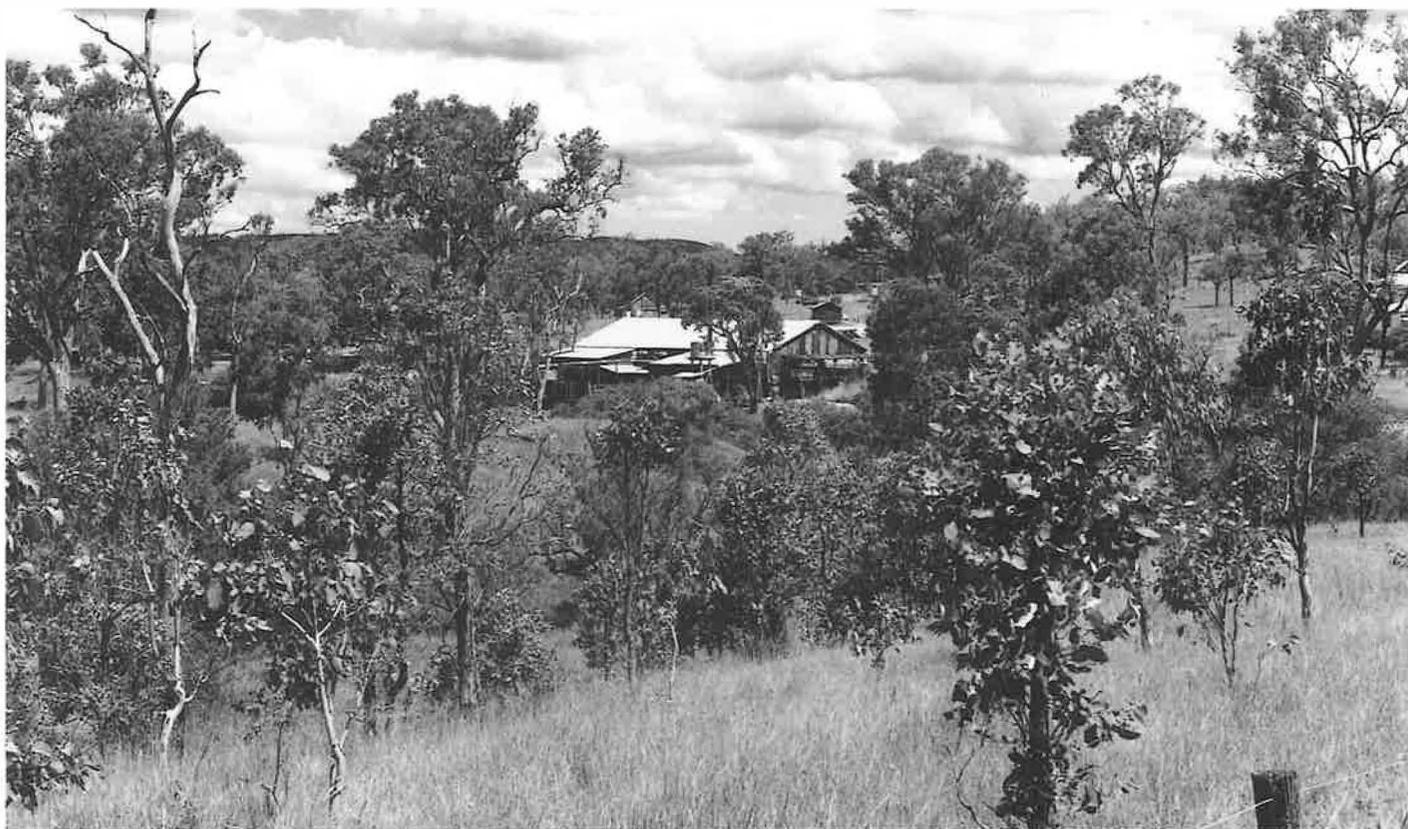
A view of the Elgin Vale Sawmill in the distance across the creek, as seen from the road from Goomeri. Some of the buildings looked as old as some of the surrounding trees. Light smoke drifted from the chimney and a little cloud of steam vapour rose up from the engine exhaust.

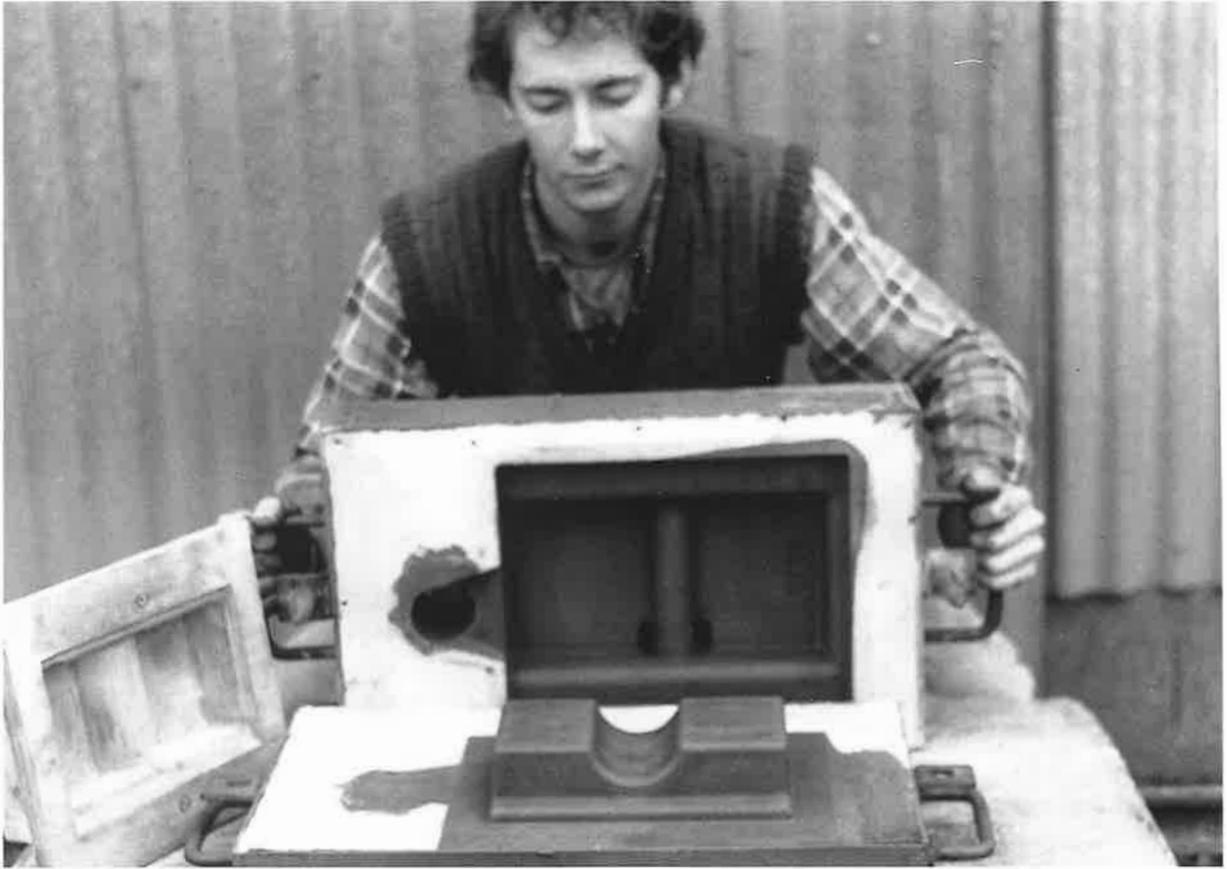
Moulder Neil Anderson is shown about to “close up” the sand mould for the new slide valve ready for casting in molten iron. The pattern which was completed only the night before is shown on the left.

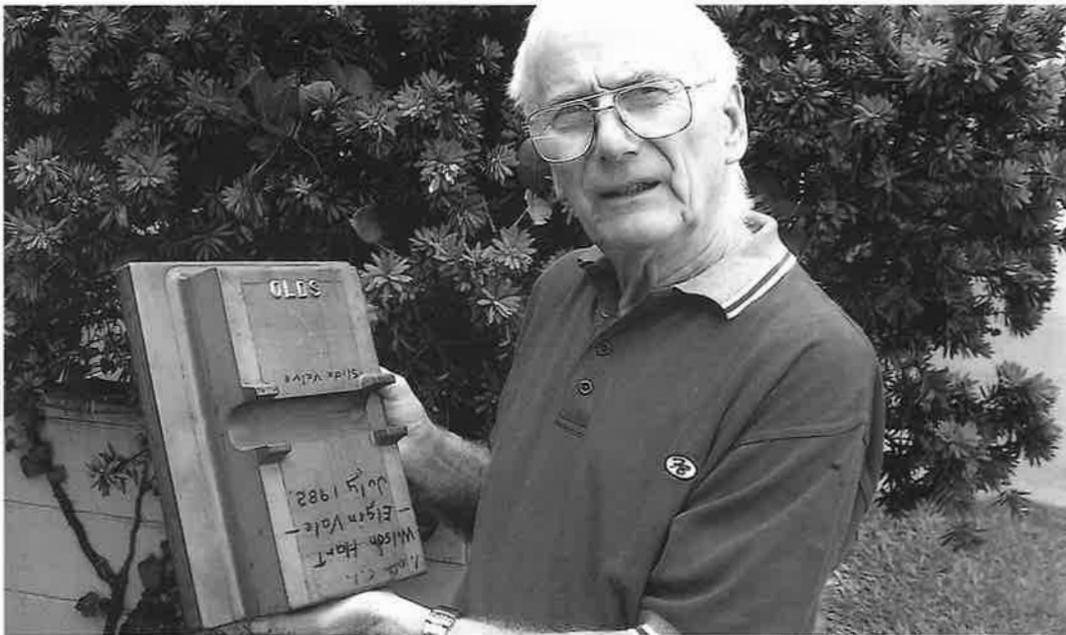
This photograph of the “back side” of the valve pattern shows the hollowed out area and lugs which engage on the valve spindle. The pattern is still as good as the “night” it was made nearly 24 years previously by a young looking Bill Baxter, seen here holding the pattern on 8/02/2006. Like all true craftsmen, Bill took great pride in his work, turning out thousands of accurate patterns many of which are most intricate.

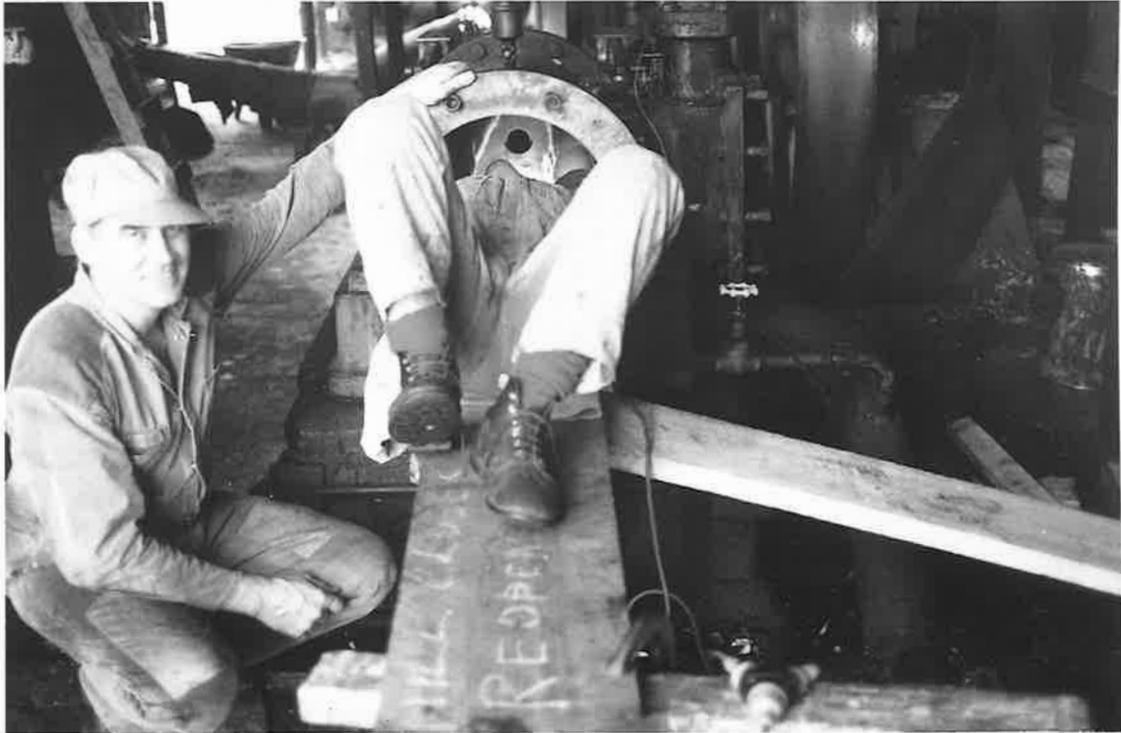
The cylinder bore was ground out and scraped to remove ridges or steps in the bore at the ends of the stroke of the old piston. Leading hand fitter machinist Alan Johnston is at the left, with third year apprentice fitter machinist John Petersen lying in the bore of the 16 3/8 inch diameter cylinder.

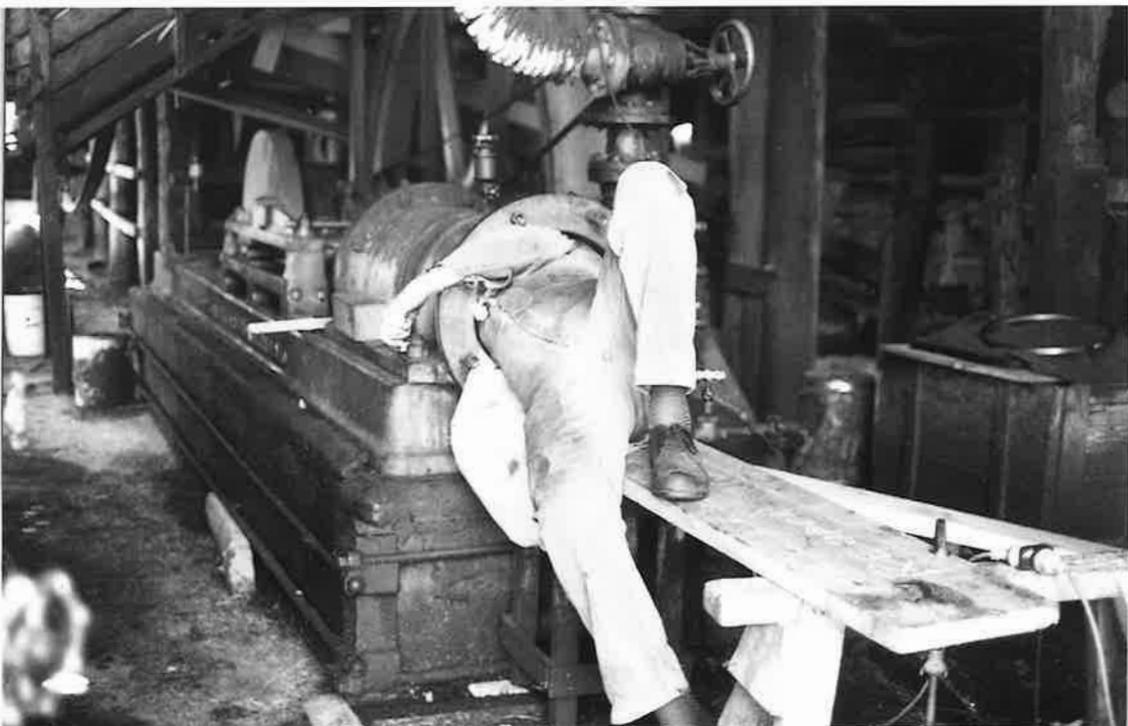
The bore, steam ports and steam chest are thoroughly cleaned out prior to assembly.

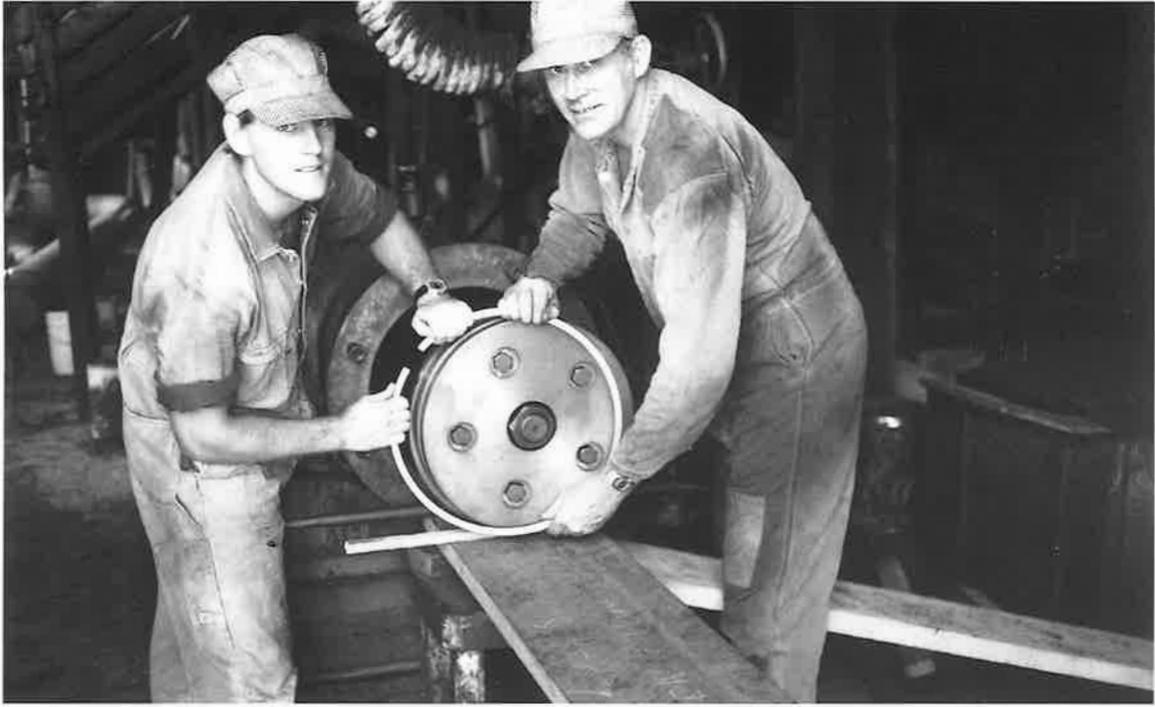
The new piston rings were first checked for "gap clearance" in the bore and then fitted to the piston. John Petersen at left with Alan Johnston.

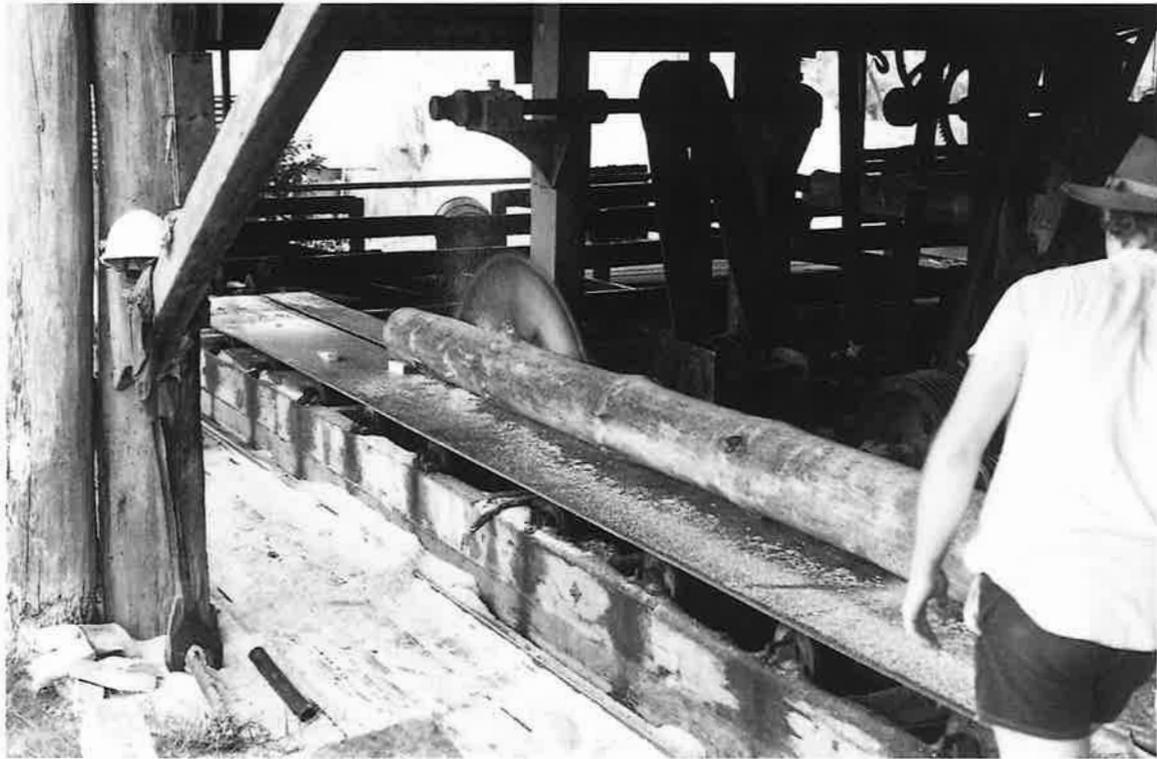
A small Hoop Pine log is fed into the single saw on the Canadian Bench with its long steel travelling table running on rollers. This photograph shows that the saw blade has been removed from the top spindle, it not being necessary when cutting small timber.

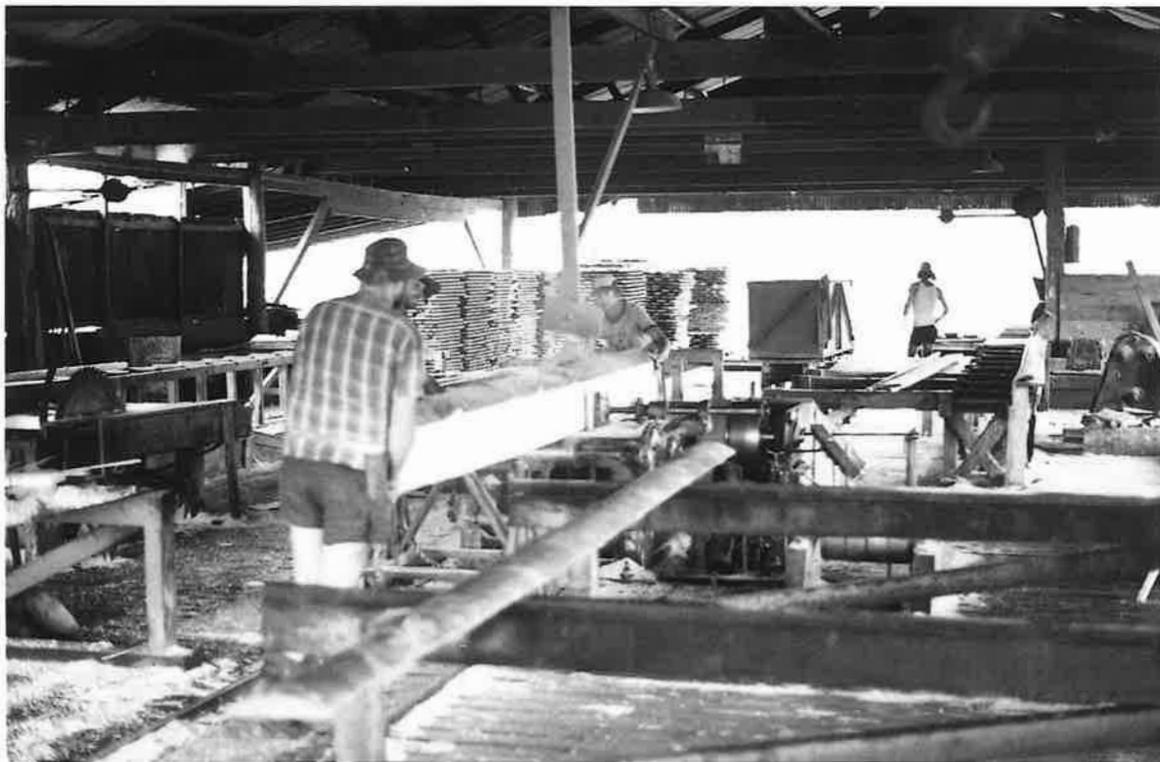
A large slab of pine is being handled by a man at each end of the heavy No. 1 saw bench, while a third man, nearly obscured by the man closest to the camera, controls the cut with the simple reversible three cylinder radial steam "feed" engine.

A light flitch can be seen on the skid rails in the centre of the photo, having just come across from the Canadian.

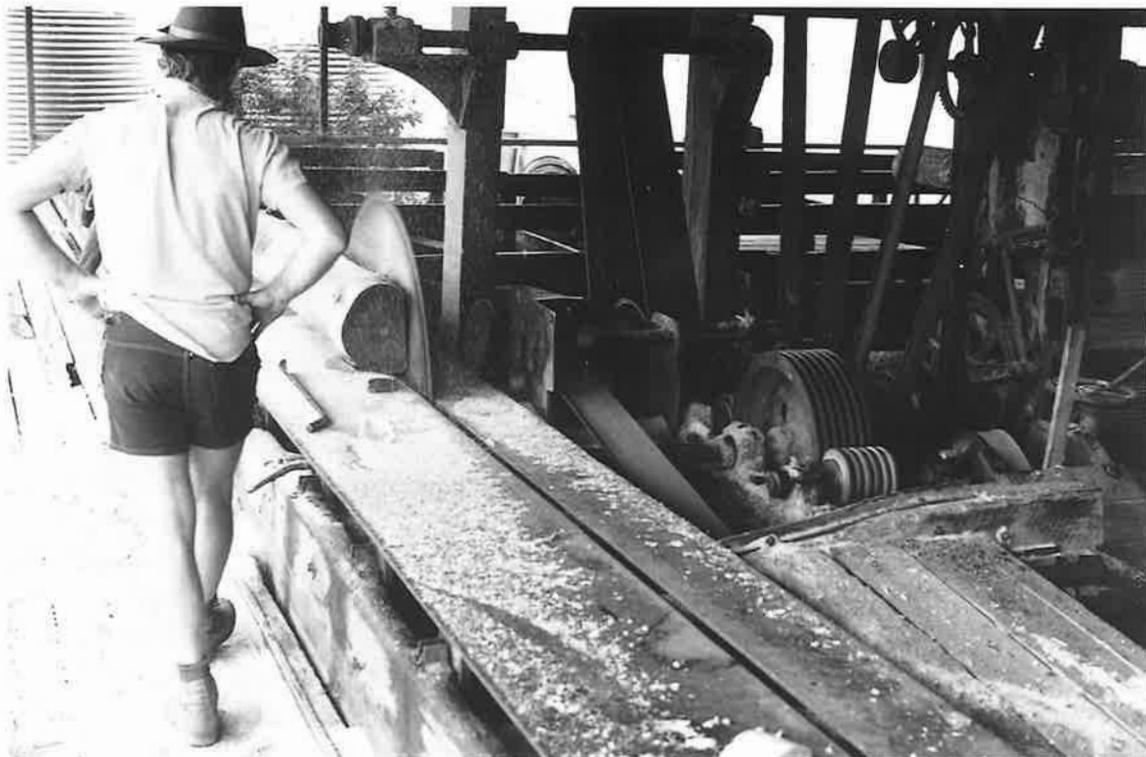
A skilled operator walks alongside the moving table or bench as the cut finishes and the flitch falls to the rails seen in the background, for transfer to the Number 1 bench. The Canadian was often referred to as a Rack bench, due to the fact that it is driven through a long gear rack fixed to the underside of the table.

The pinion gear meshing with the rack is driven through a friction drive, which is visible in the centre right of the picture. This device works as an effective friction clutch, which gives the operator smooth control over the heaviest of the logs being fed into the saws.

(The small multi V grooved fibre friction roller had just been replaced when this photo was taken.)
